# Guam Waterworks Authority (VP0989)

## CWA Collection System

Tumon, Guam

NEIC Field Investigation Photographs  
April 24 through May 4

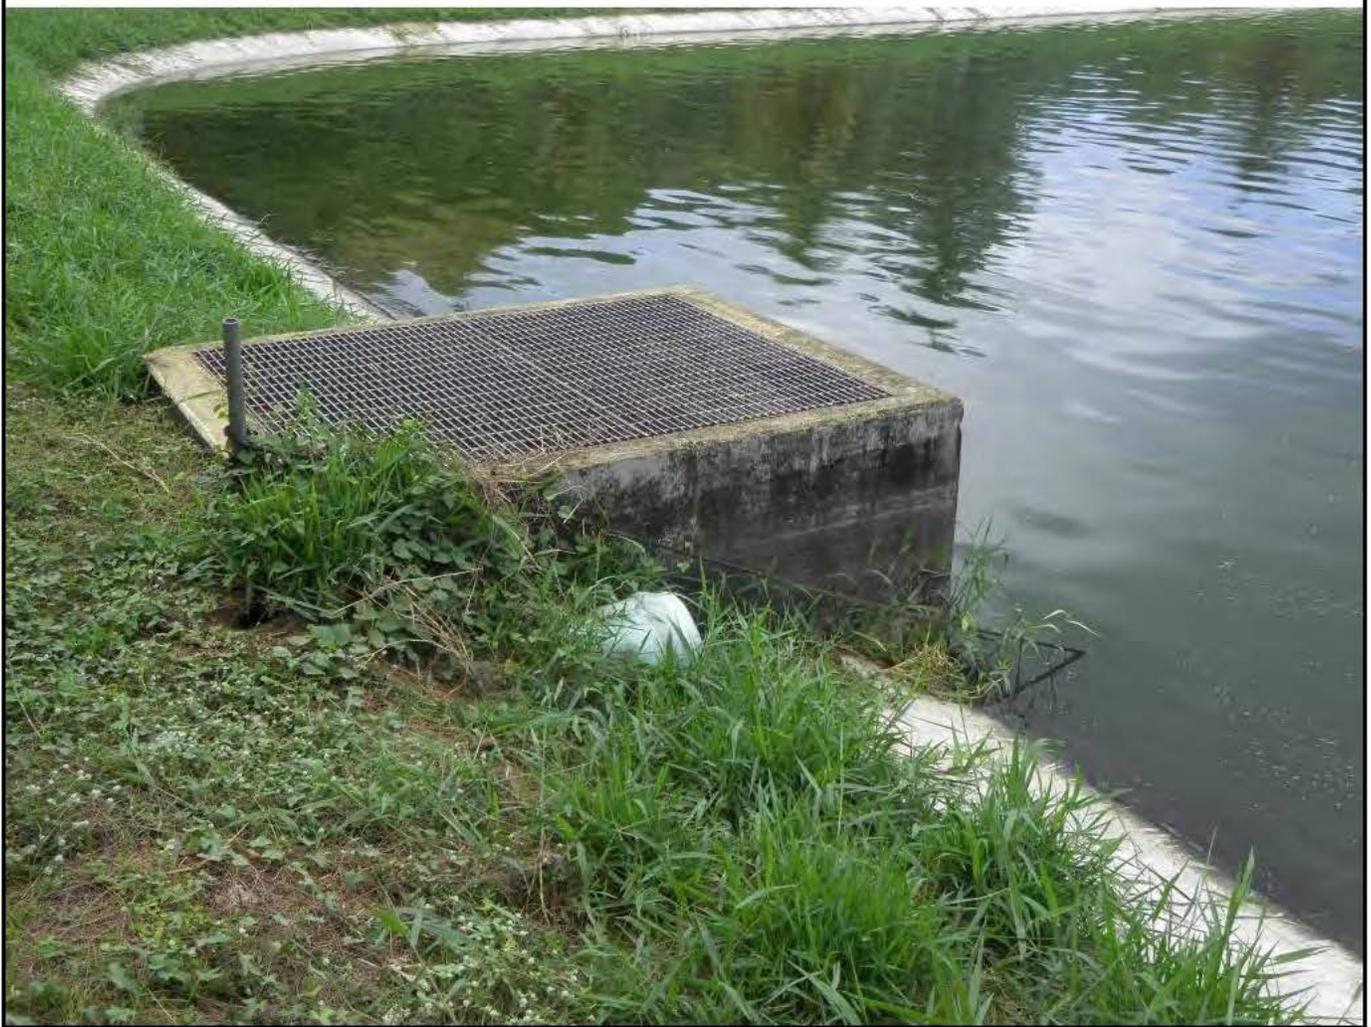
File Name: RIMG0027.JPG

<b>Title</b>	Guam Waterworks Authority (VP0989)
<b>Subject</b>	CWA Collection System
<b>Date Time Stamp</b>	4/26/2012 10:23:11 AM
<b>Photographer</b>	D. Vanlerberghe
<b>Description</b>	Inlet pipe for emergency overflow for lagoon at Umatac WWTP

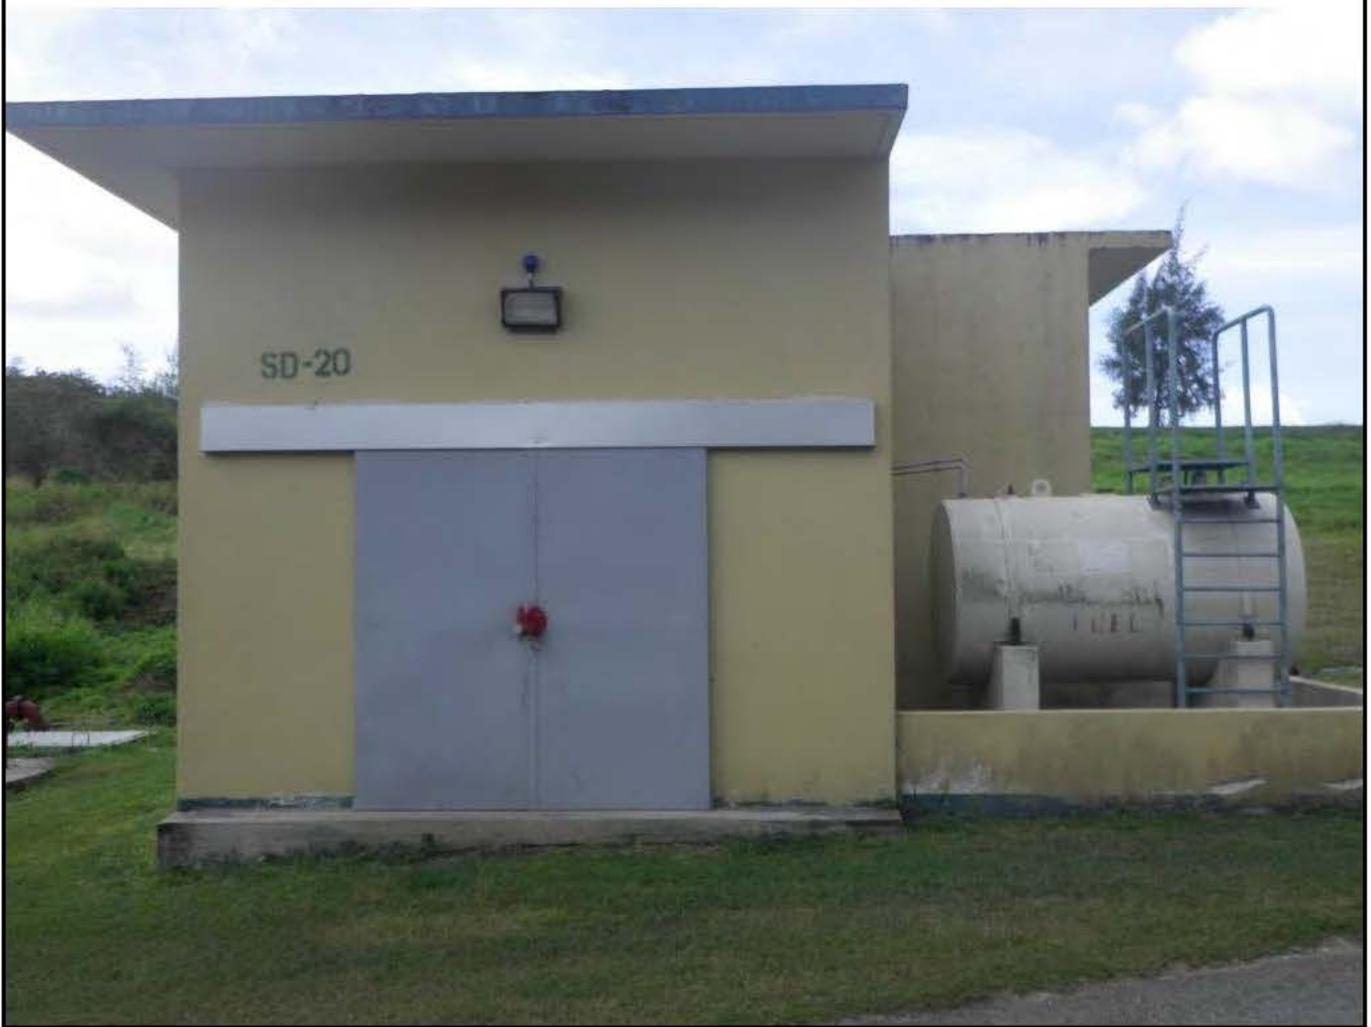
File Name: RIMG0029.JPG

Title	Guam Waterworks Authority (VP0989)
Subject	CWA Collection System
Date Time Stamp	4/26/2012 10:42:08 AM
Photographer	D. Vanlerberghe
Description	Recirculation pump station No. 20 for percolation beds at Umatac WWTP

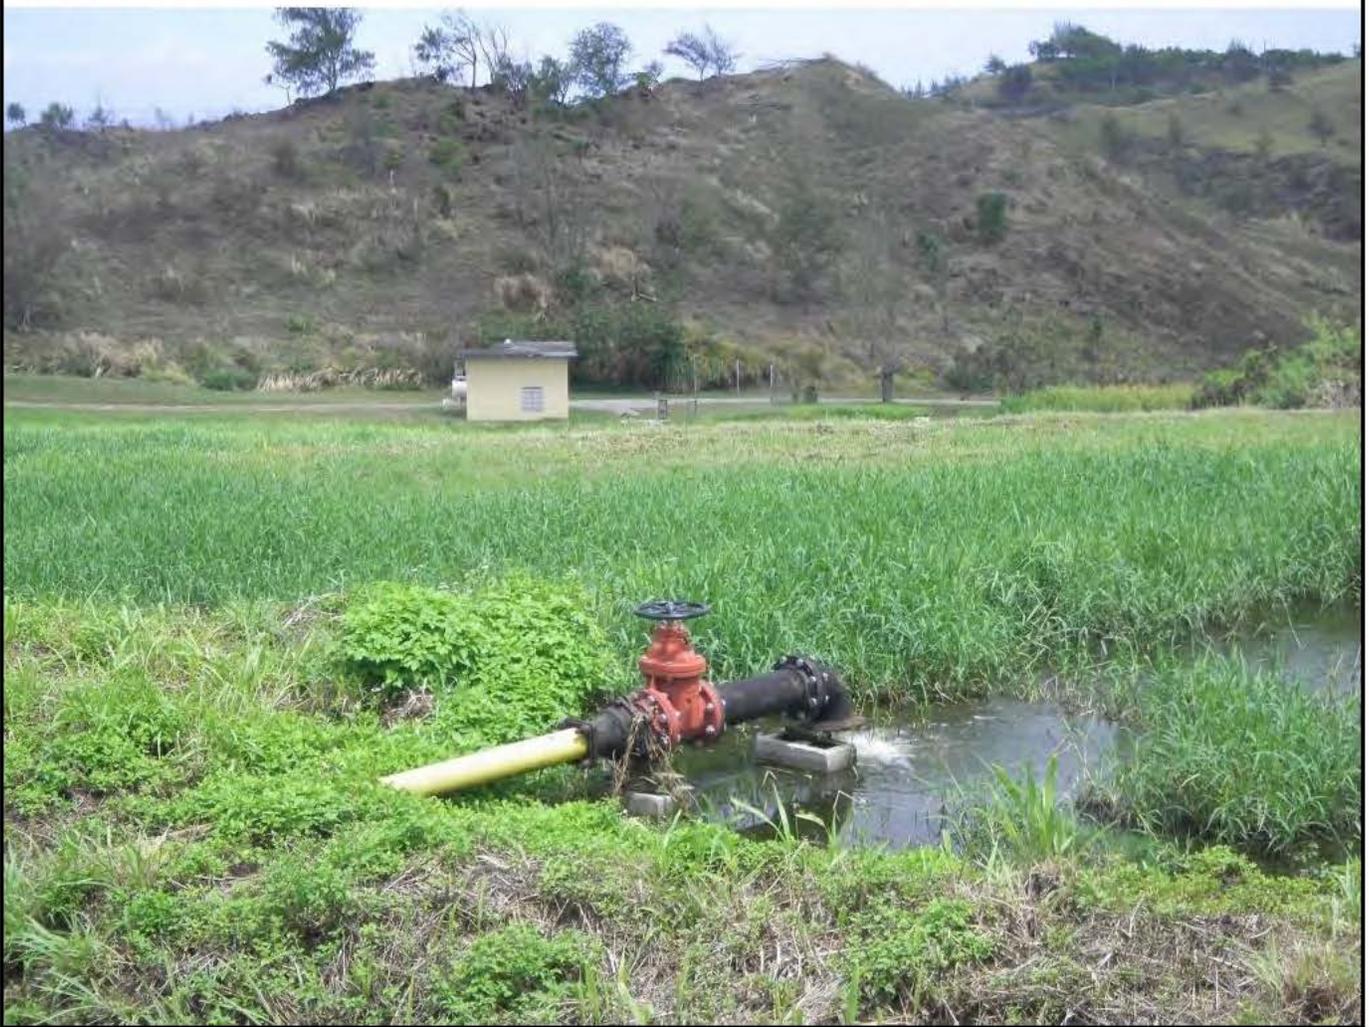
File Name: RIMG0030.JPG

Title	Guam Waterworks Authority (VP0989)
Subject	CWA Collection System
Date Time Stamp	4/26/2012 10:47:24 AM
Photographer	D. Vanlerberghe
Description	Top of percolation bed field A, pump station No. 20 in background at Umatac WWTP

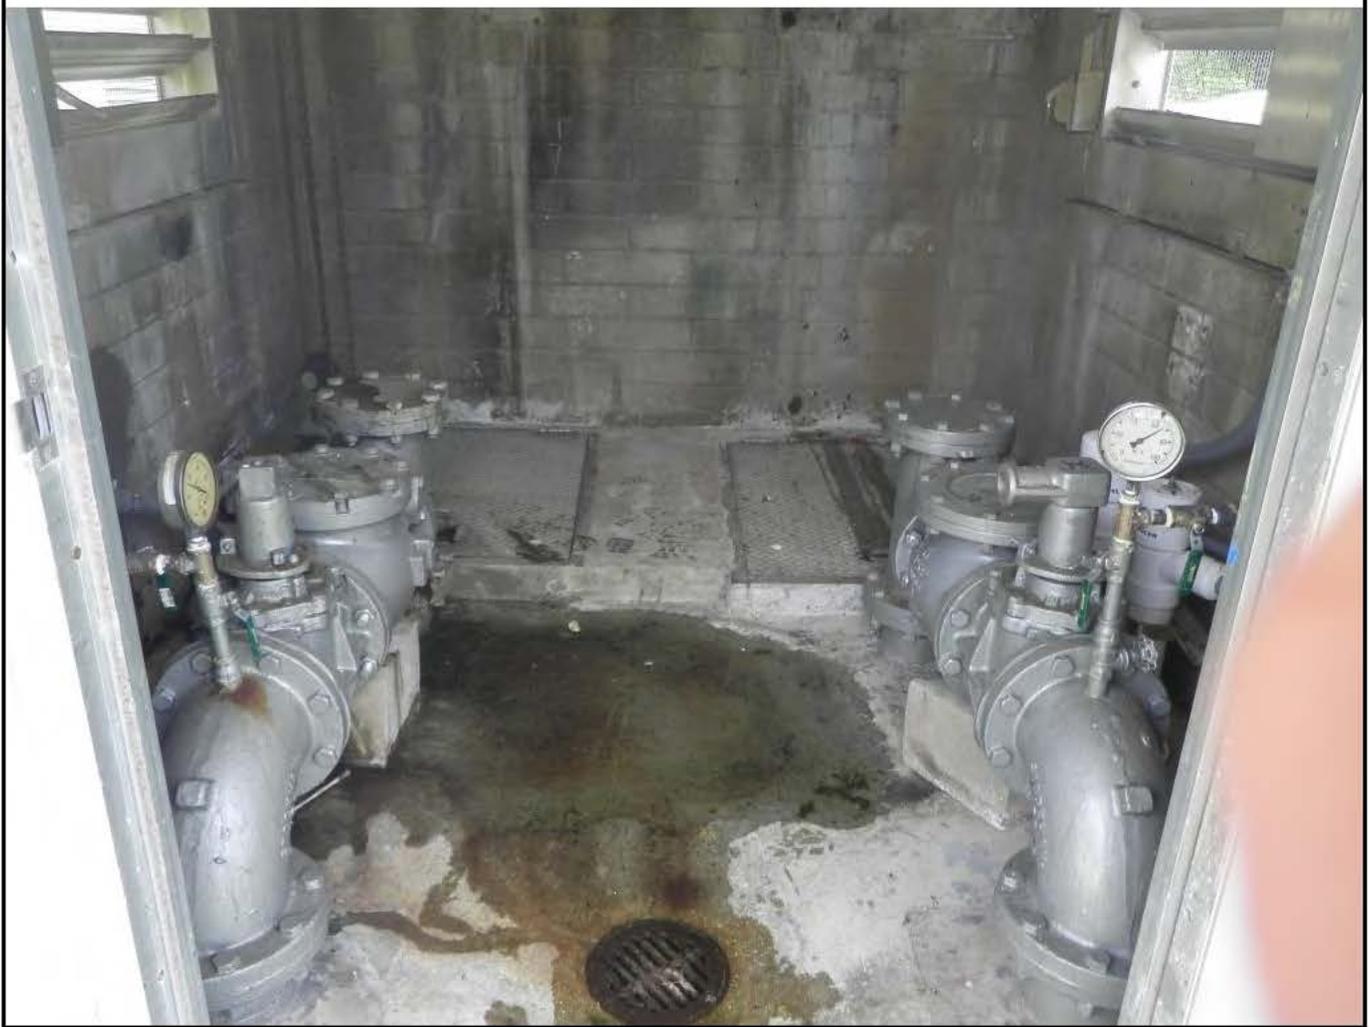
File Name: RIMG0031.JPG

Title	Guam Waterworks Authority (VP0989)
Subject	CWA Collection System
Date Time Stamp	4/26/2012 11:09:14 AM
Photographer	D. Vanlerberghe
Description	Pump station No. 19 pumps at Umatac WWTP for pumping lagoon effluent to percolation beds

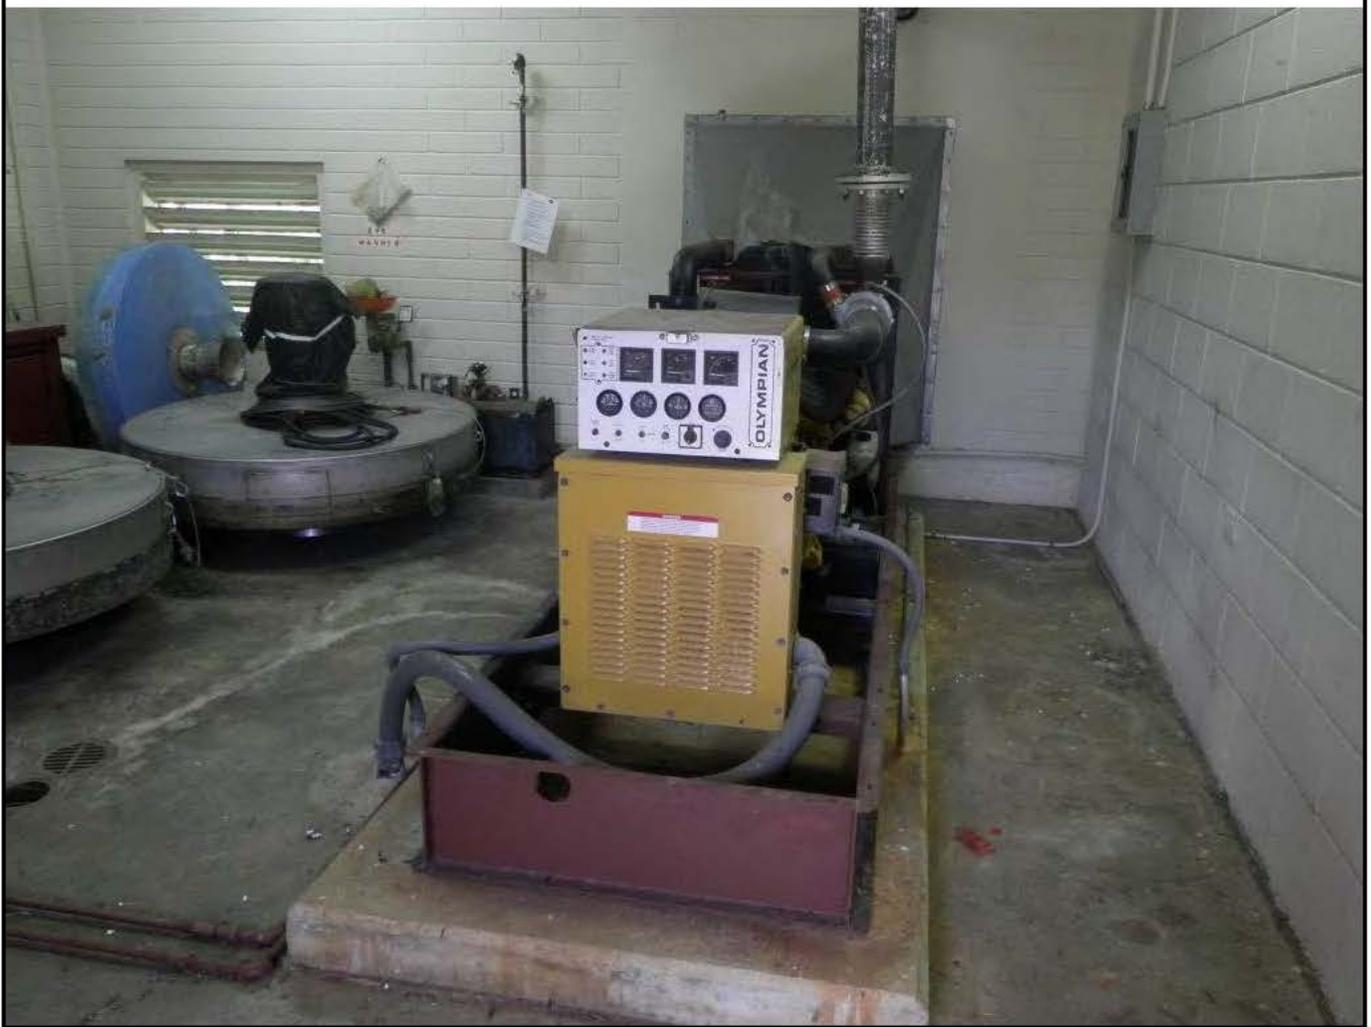
File Name: RIMG0032.JPG

Title	Guam Waterworks Authority (VP0989)
Subject	CWA Collection System
Date Time Stamp	4/26/2012 11:14:50 AM
Photographer	D. Vanlerberghe
Description	Pump station No. 19 standby generator at Umatac WWTP

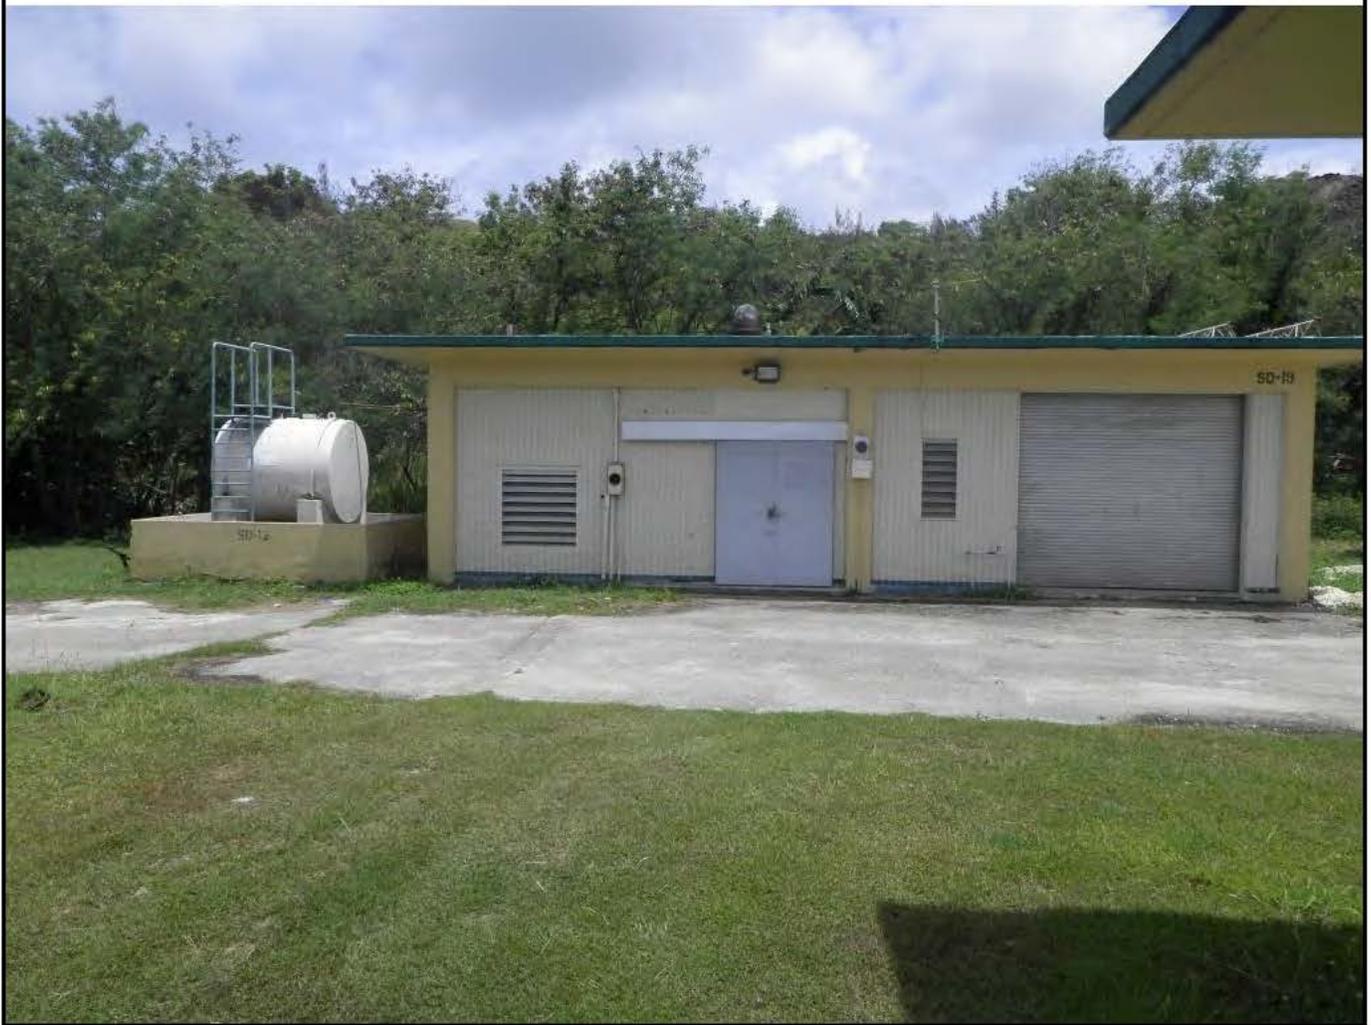
File Name: RIMG0033.JPG

Title	Guam Waterworks Authority (VP0989)
Subject	CWA Collection System
Date Time Stamp	4/26/2012 11:19:03 AM
Photographer	D. Vanlerberghe
Description	Pump station No. 19 building at Umatac WWTP

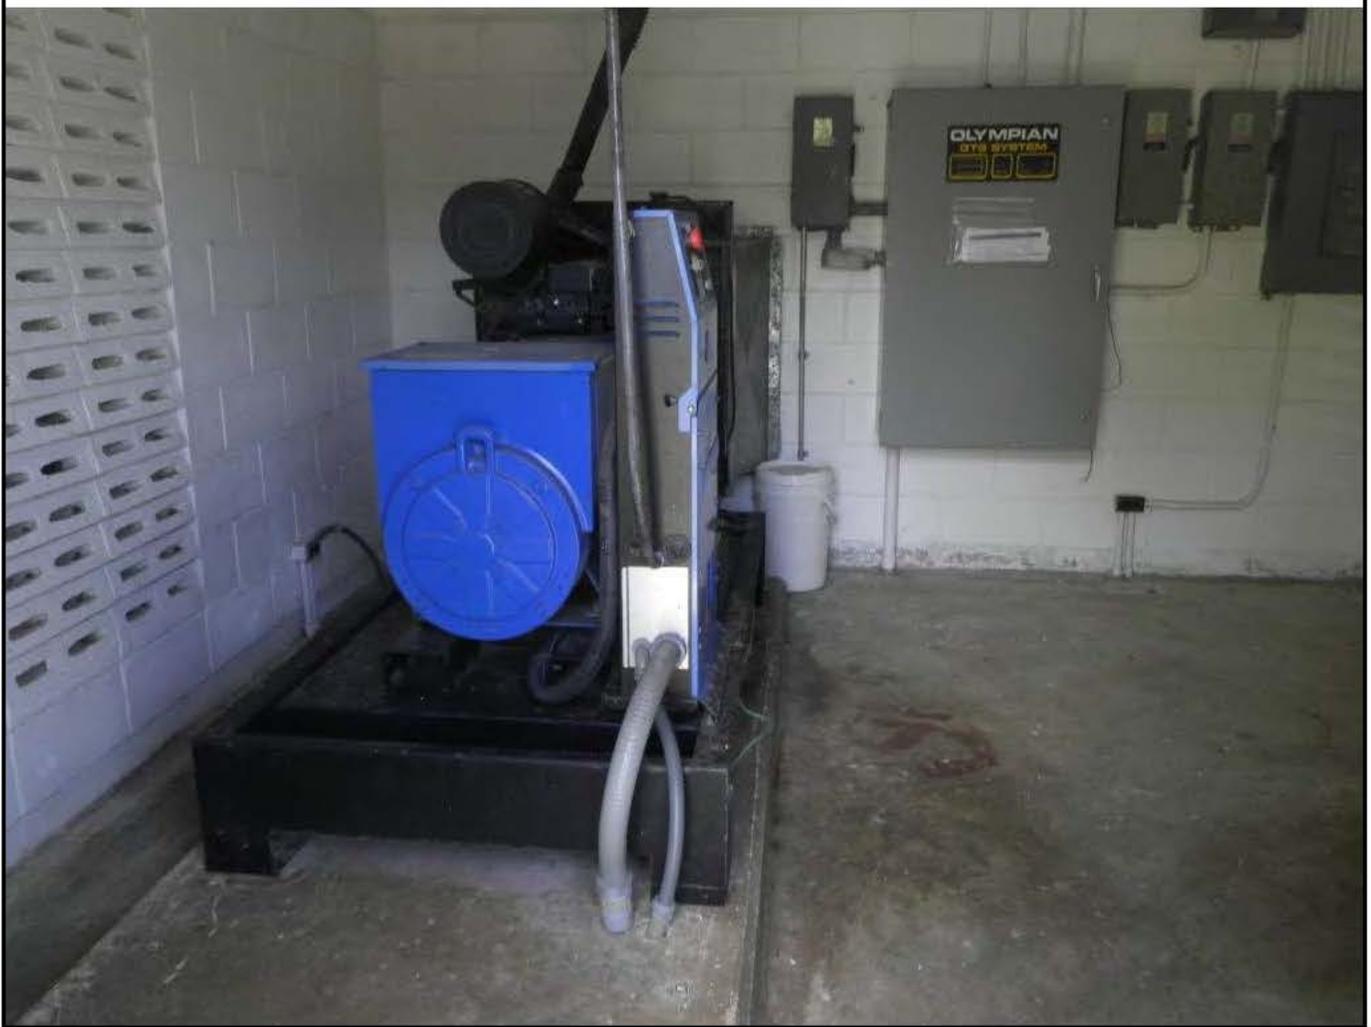
File Name: RIMG0034.JPG

Title	Guam Waterworks Authority (VP0989)
Subject	CWA Collection System
[REDACTED]	[REDACTED]
[REDACTED]	[REDACTED]
Date Time Stamp	4/26/2012 12:05:55 PM
Photographer	D. Vanlerberghe
Description	Inarajan lift pump station standby generator

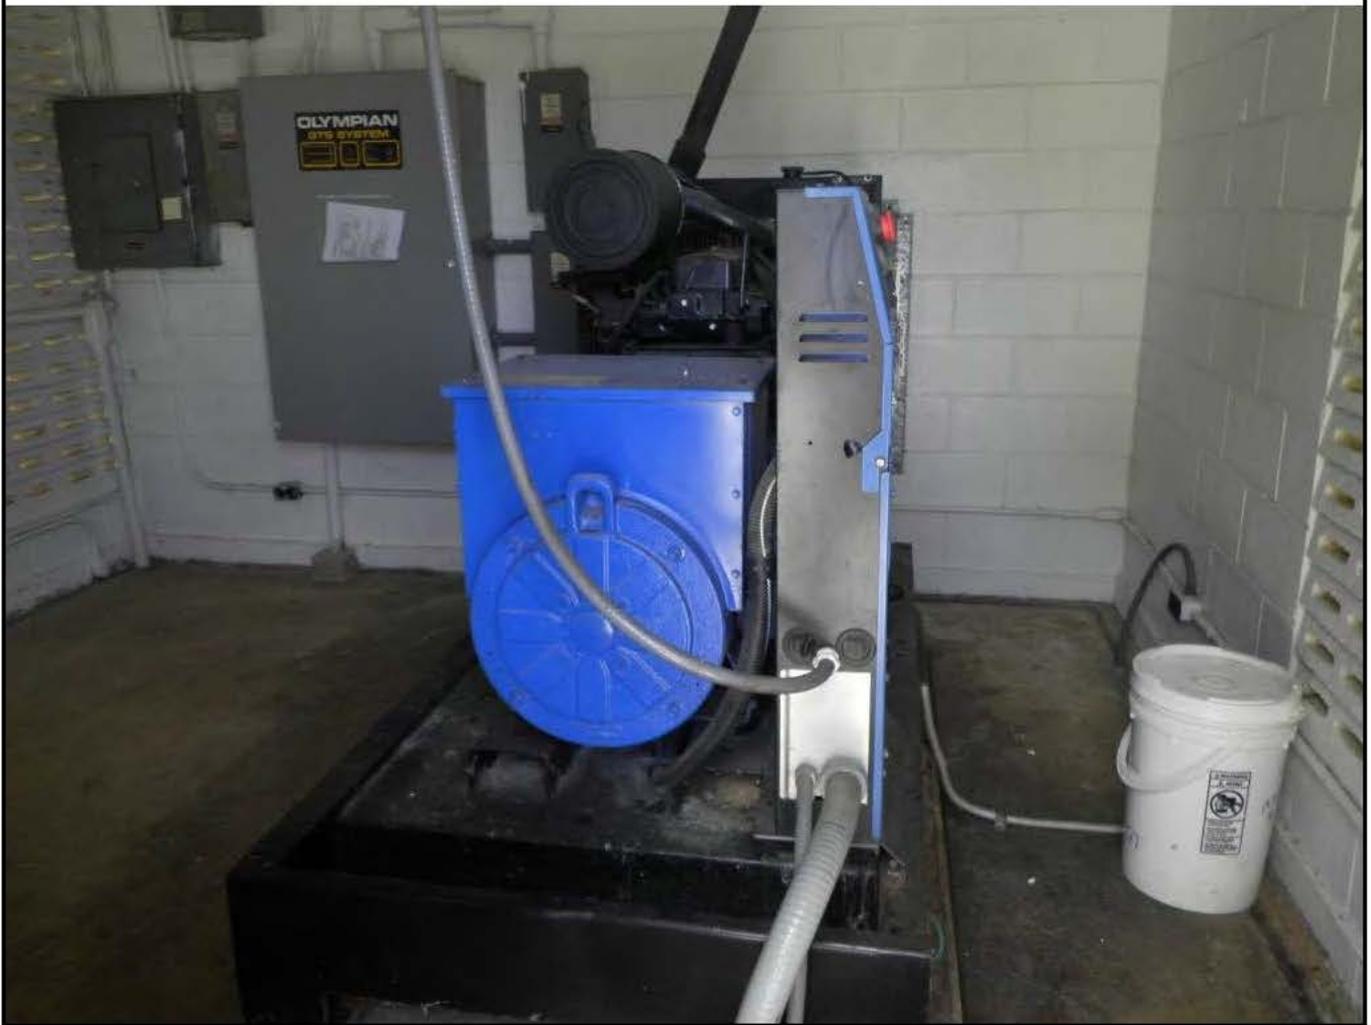
File Name: RIMG0038.JPG

Title	Guam Waterworks Authority (VP0989)
Subject	CWA Collection System
Date Time Stamp	4/26/2012 12:22:49 PM
Photographer	D. Vanlerberghe
Description	Inarajan main pump station standby generator

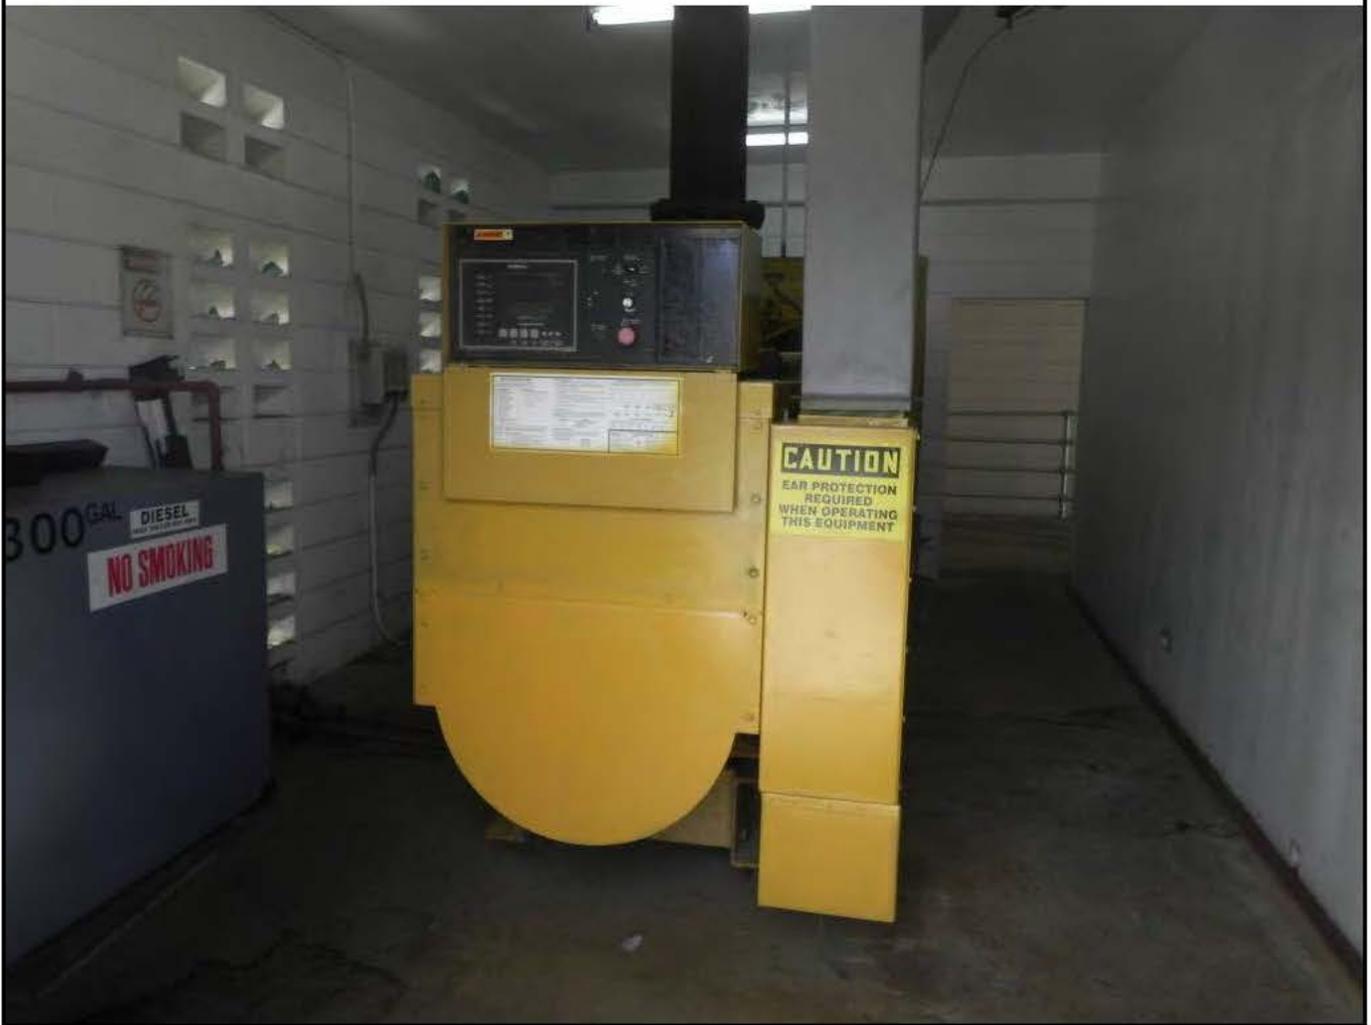
File Name: RIMG0041.JPG

Title	Guam Waterworks Authority (VP0989)
Subject	CWA Collection System
Date Time Stamp	4/27/2012 10:10:32 AM
Photographer	D. Vanlerberghe
Description	Fujita pump station stanby generator

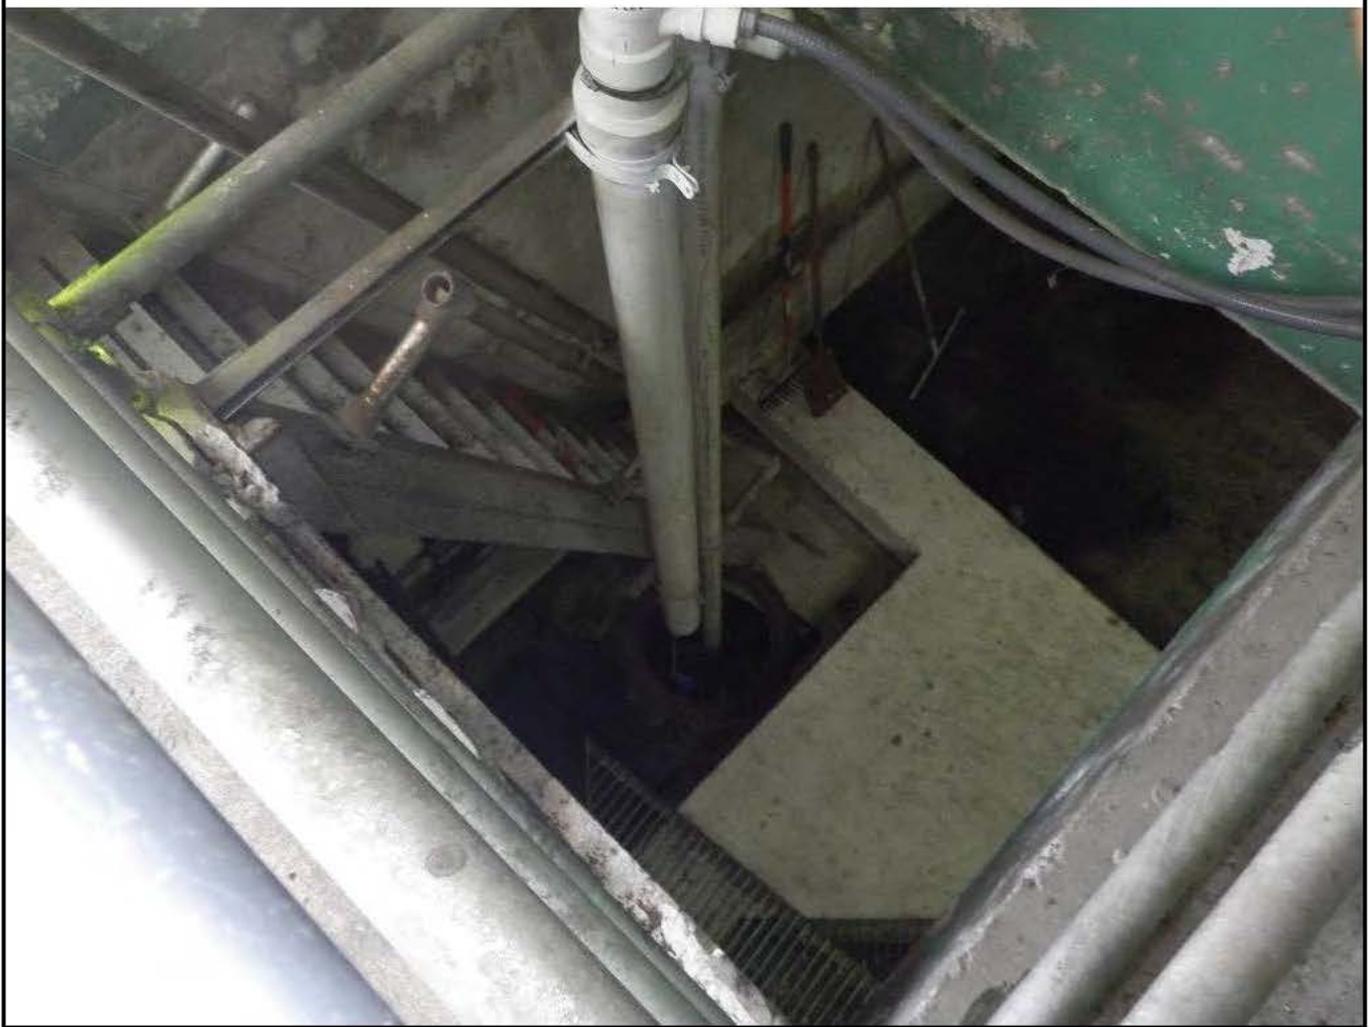
File Name: RIMG0042.JPG

Title	Guam Waterworks Authority (VP0989)
Subject	CWA Collection System
[REDACTED]	[REDACTED]
[REDACTED]	[REDACTED]
Date Time Stamp	4/27/2012 10:11:08 AM
Photographer	D. Vanlerberghe
Description	Fujita pump station wet well, showing level sensor and float

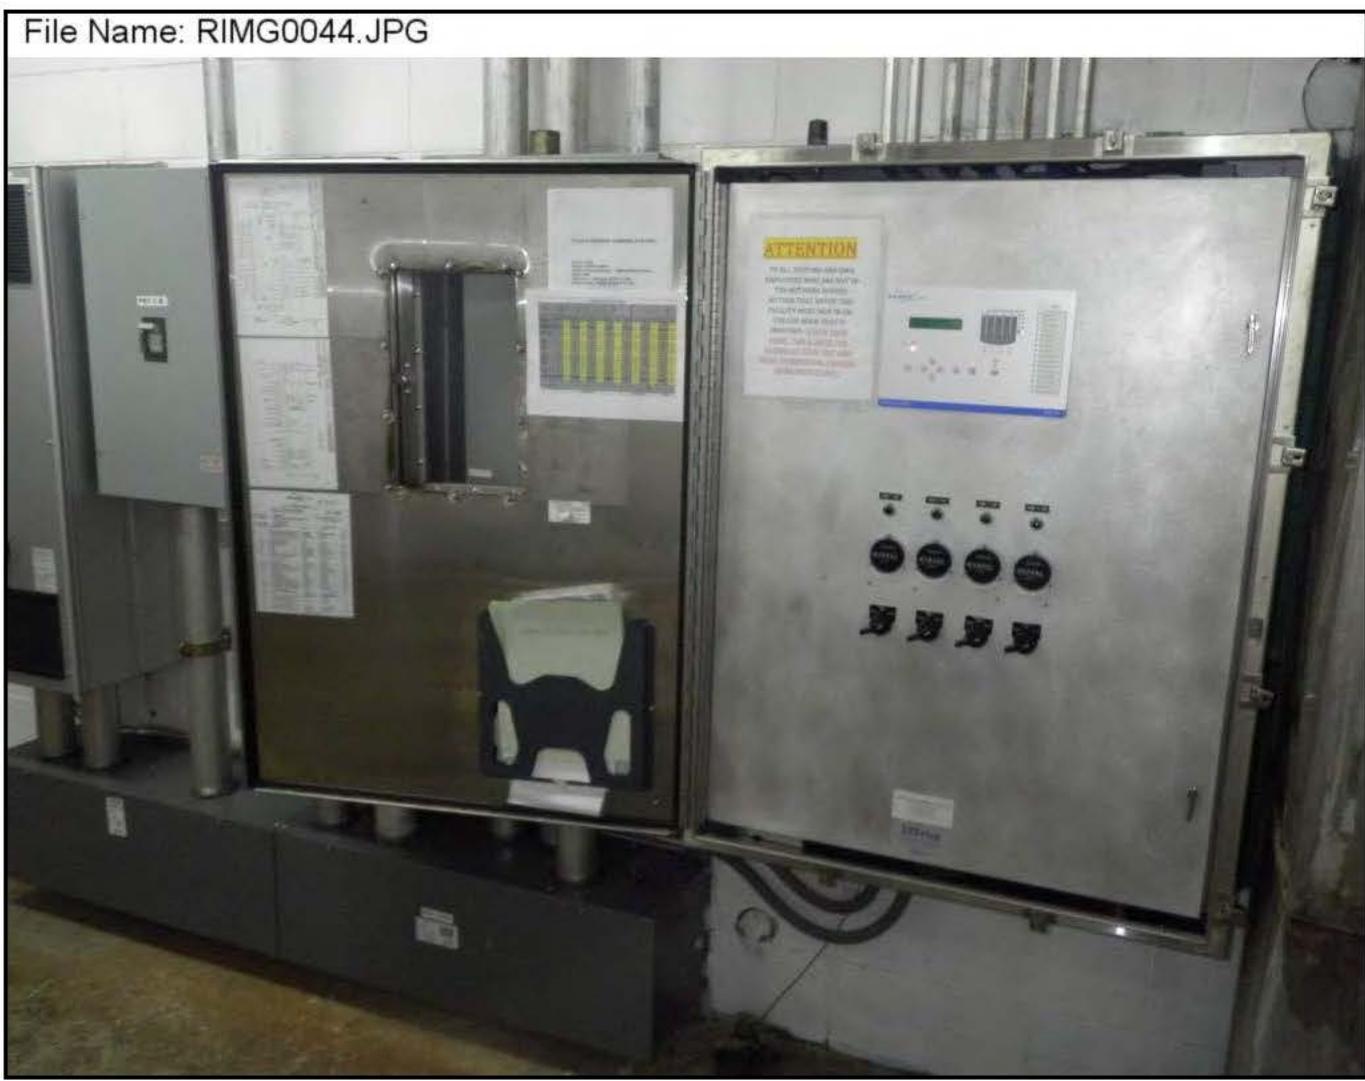
Attributes	
Title	Guam Waterworks Authority (VP0989)
Subject	CWA Collection System
Date Time Stamp	4/27/2012 10:13:37 AM
Photographer	D. Vanlerberghe
Description	Fujita pump station SCADA control panel

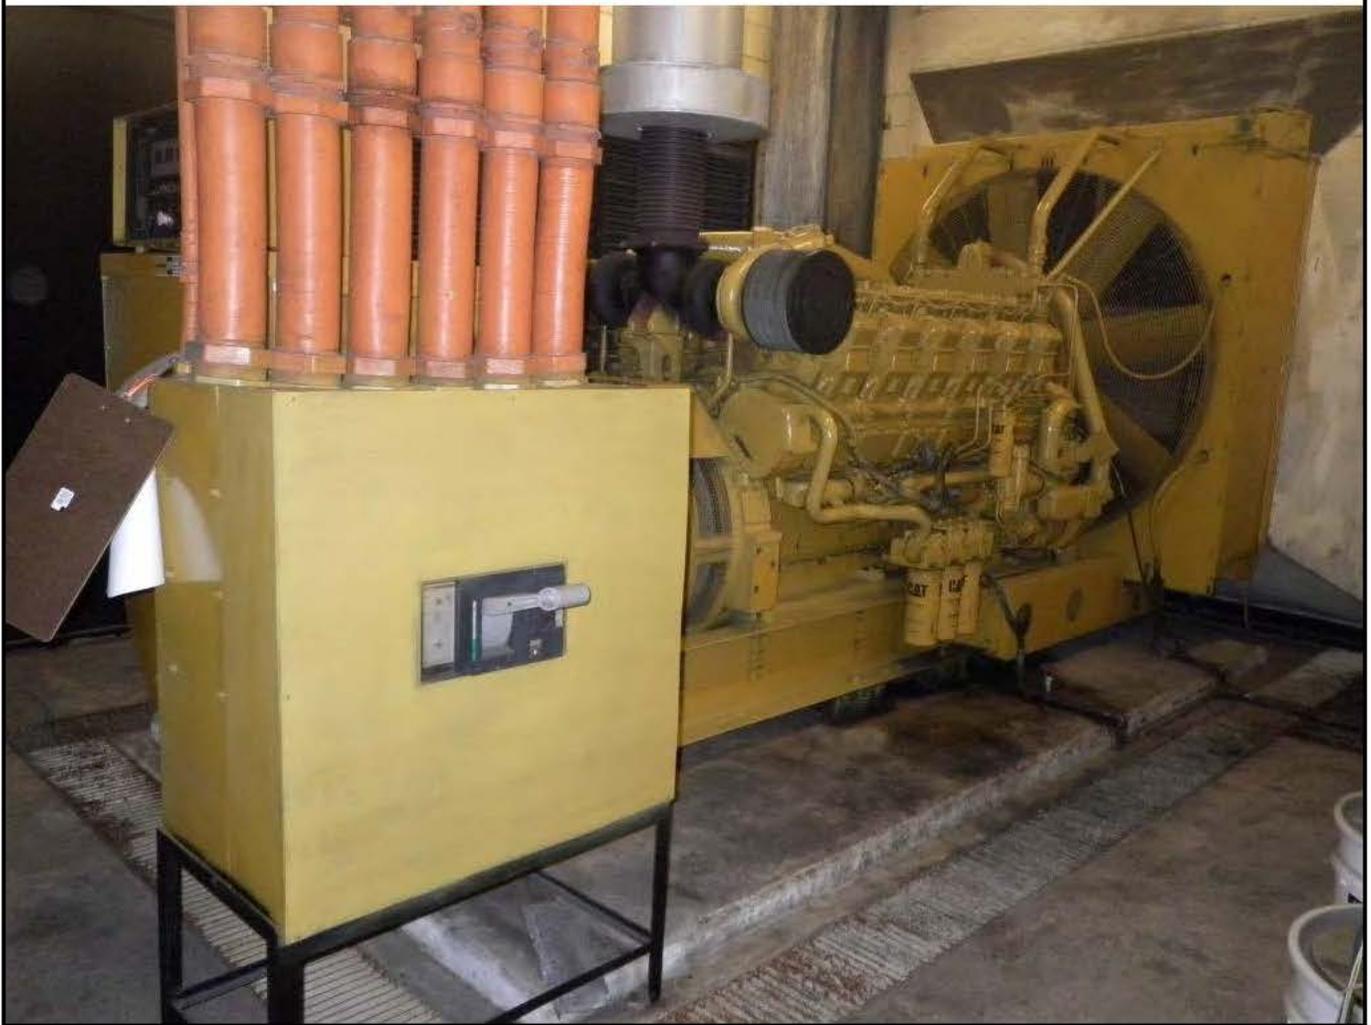
File Name: RIMG0047.JPG

Title	Guam Waterworks Authority (VP0989)
Subject	CWA Collection System
Date Time Stamp	4/27/2012 10:53:13 AM
Photographer	D. Vanlerberghe
Description	Route 16 pump station standby generator

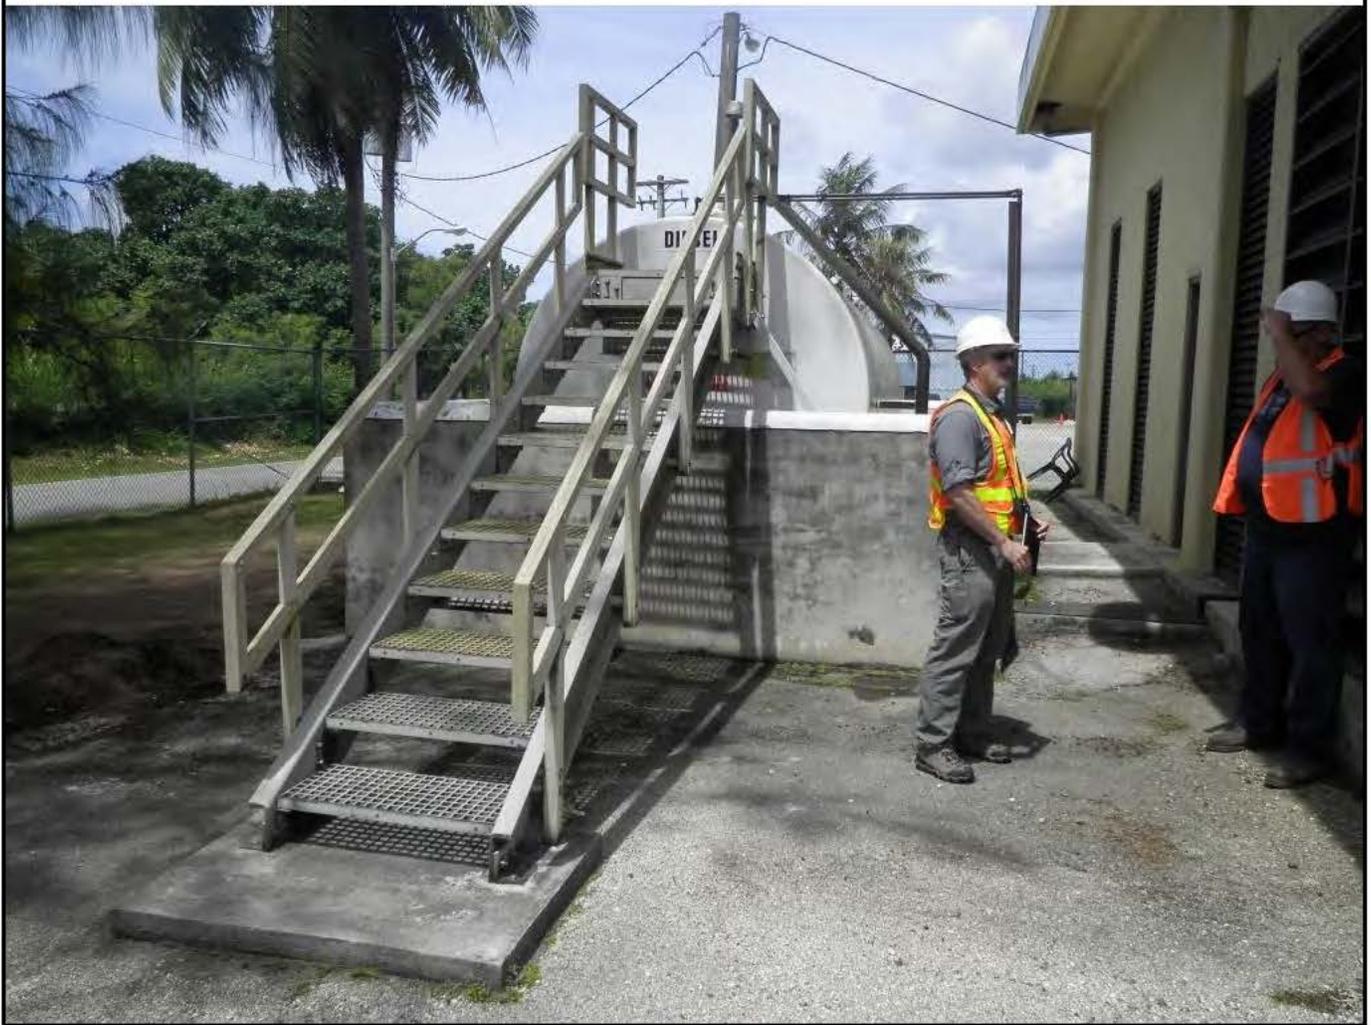
File Name: RIMG0049.JPG

Title	Guam Waterworks Authority (VP0989)
Subject	CWA Collection System
Date Time Stamp	4/27/2012 10:57:23 AM
Photographer	D. Vanlerberghe
Description	Route 16 pump station diesel fuel tank

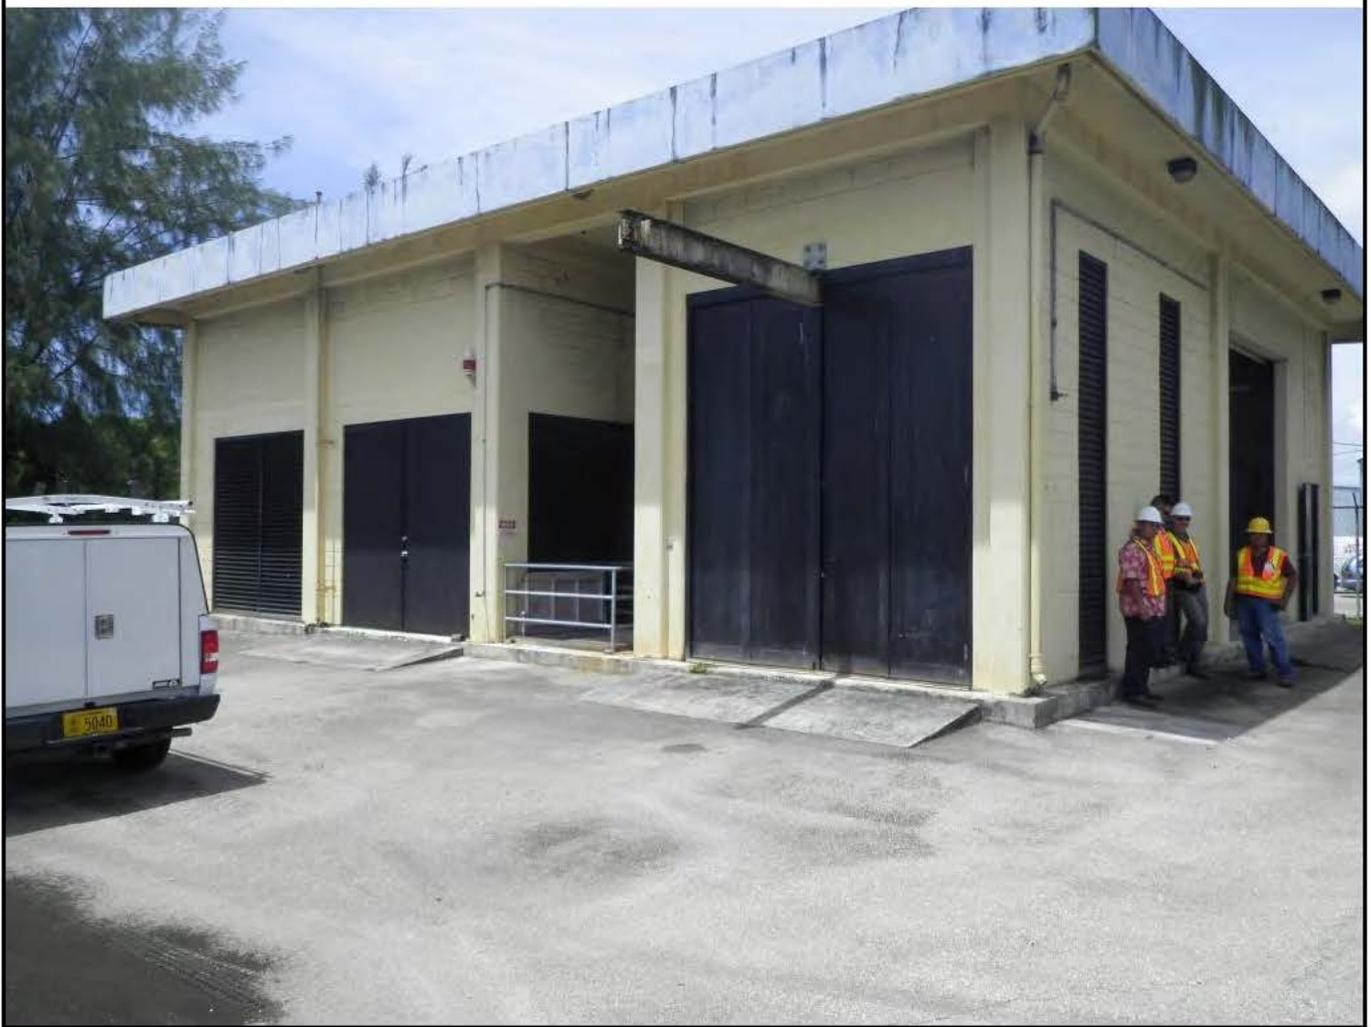
File Name: RIMG0050.JPG

Title	Guam Waterworks Authority (VP0989)
Subject	CWA Collection System
Date Time Stamp	4/27/2012 11:09:18 AM
Photographer	D. Vanlerberghe
Description	Route 16 pump station building

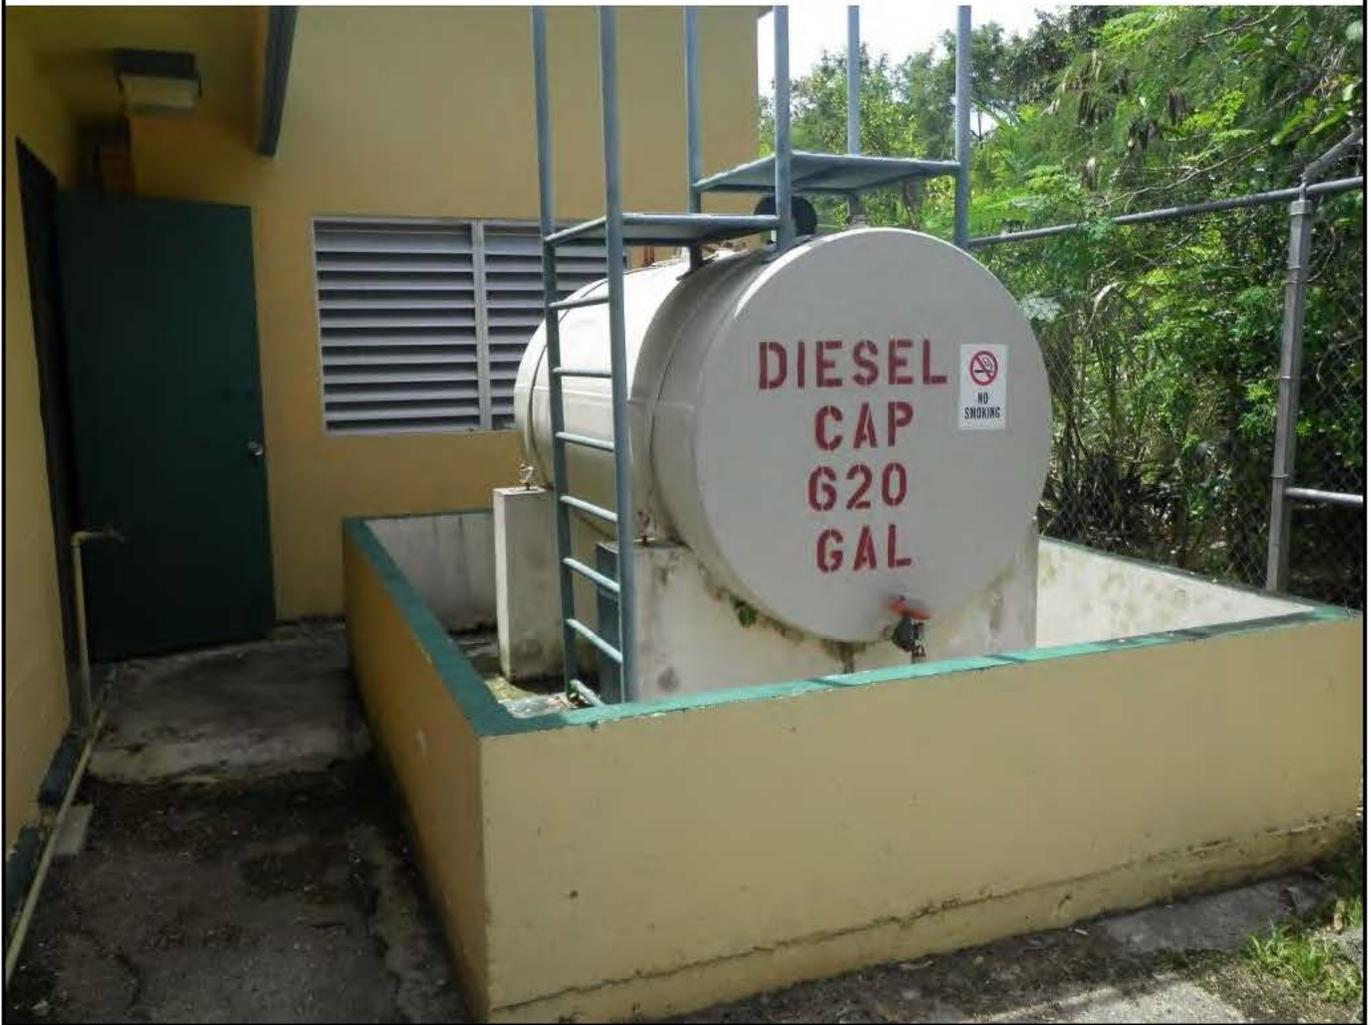
File Name: RIMG0052.JPG

Title	Guam Waterworks Authority (VP0989)
Subject	CWA Collection System
Date Time Stamp	4/27/2012 1:35:23 PM
Photographer	D. Vanlerberghe
Description	Double Trouble pump station diesel fuel tank
